To cite this article: Desiran Sembiring, Daud Surbakti and Ab Saman (2025). FAILURE ANALYSIS OF WATER TUBE BOILER: CASE STUDY AT TEXTILE PROCESSING PLANT, International Journal of Current Research and Applied Studies (IJCRAS) 4 (2): Article No. 116, Sub Id 199

## **FAILURE ANALYSIS OF WATER TUBE BOILER: CASE STUDY AT TEXTILE PROCESSING PLANT**

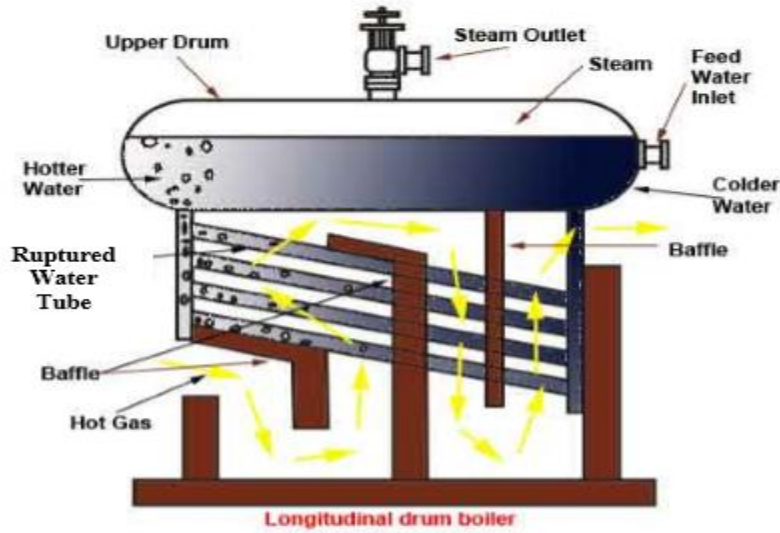
**Fig. 1 - Ruptured tubes position**

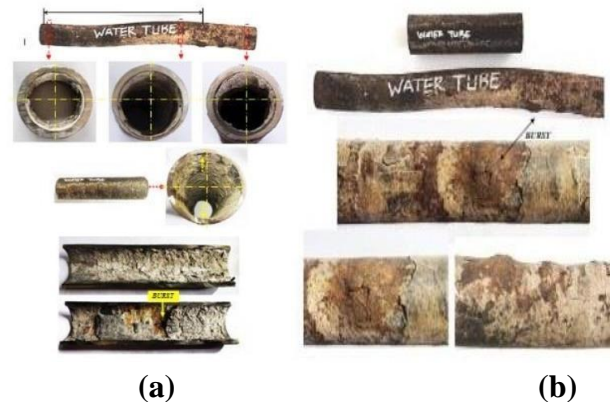
The visual observation of Fig. 3 showed that the condition of tubes experienced a bulging before it burst (ruptured).

**Fig. 3 - Visual inspection and test position of boiler tubes. (a) Macro graphical tubes that suffered damage leaks (burst) part of the tubes on the fireside; (b) The macro graphic of the surface of the water tube boiler on the waterside experienced a burst.**

There is a build-up of combustion scale/deposit while on the inside, there is a white scale, expected as silica. From the results of these visual observations, it is also seen that there are corrosion products throughout the fireside of the tubes in Fig. 3(a), which is brownish yellow and rough. The presence of corrosion products indicates a reaction of fuel gas and is exposed to temperatures above normal that should be accepted by the tubes' material. Stacking scale deposits in the area burst had hot spots that reduce their thickness because of the oxide reaction or corrosion.

Where as in Fig. 3(b) the surface of the boiler tubes on the waterside that experienced burst. A build-up of scale/combustion deposit is quite thick and layered with different colors. The precipitate that formed stuck to the tubes' surface is brownish-black like iron oxide, which occurred due to the high temperatures exposed in the air, while the scale layers/sediment preconceived white, thick, and hard thought to be a compound of silica produced by water.

- The results of the analysis of visual observations showed that the boiler tube is damaged in the shape of a fish mouth. There has been overheating. This is an indication that there is overheating that can cause bulging during the operation in the tubes.

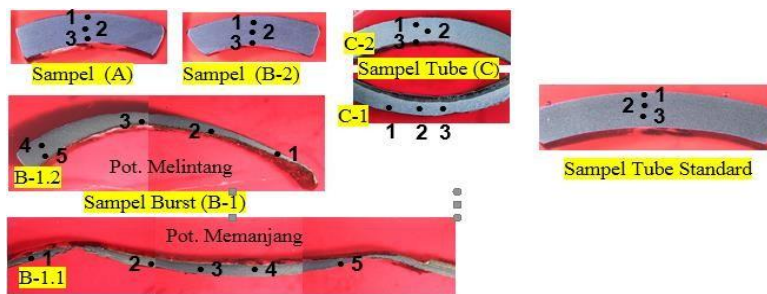
Hardness testing is carried out on the damaged area and the undamaged area according to figures 4 and 5, where each region gets data 3 times. The comparison of hardness testing of the damage tubes and intact tubes showed that the hardness decreased in areas far from the burst around 117-105 HV, but the hardness increased in the burst area 117 - 119 HV due to a change in the ferrite-pearlite phase into pearlite spheroidization (Fig. 14). However, when compared to standard ASTM 213 material, its hardness value is 178 HV. This is away different from the intact water tube boiler material. It means that the tube's material used has a hardness value of 117 HV. Table 4 showed the tensile test result of the specimens. The tubes' overall tensile strength is reduced due to a softening process caused by annealing temperature > 550 °C. The tensile strength decreased by approximately 11.5% and a yield strength decline of about 16.25% as well as the elongation decreased by around 14.8%. However, when compared with the standard ASTM 213 material, it is not much different from the intact tube material, meaning that the tube material which was chosen and used was good.

**Fig. 5 - Position of the hardness test on a ruptured water tube boiler**

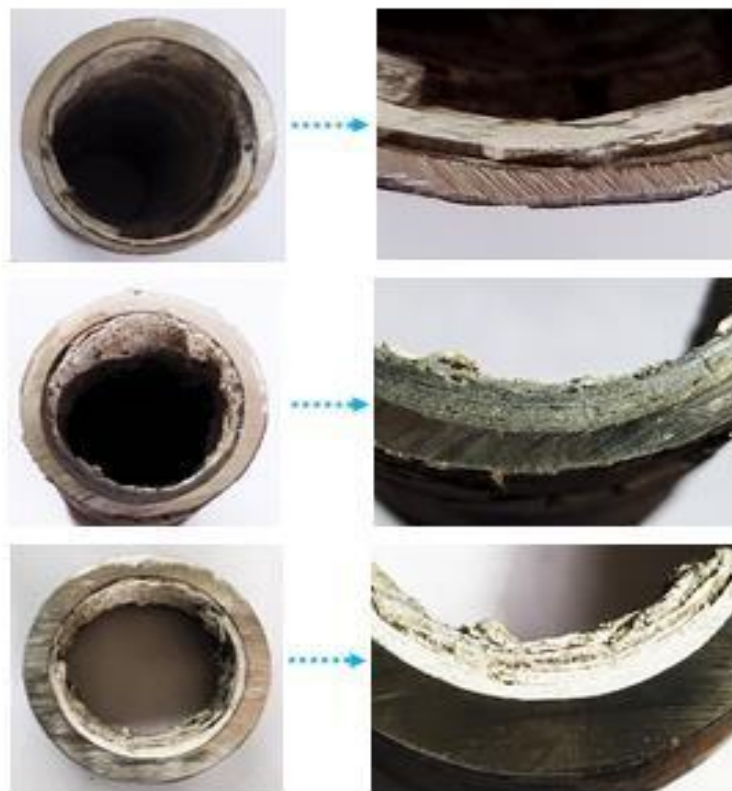
Based on the macro-observations presented in Fig. 6, it is clear that there was a deposit of water crust (scale) inside the tube. The existence of the crust can disrupt the heat transfer mechanism of the system and make the tube overheats. Moreover, XRF analysis (Fig.7 and Table 5) and SEM-EDS analysis (Fig.8) was subjected to find out the chemical composition of the crust. The results present the elements of the crust that the majority of elements include oxygen, sulfur, sodium, silica, magnesium, and calcium. The data confirm that the crust strongly suspected is an oxide compound.

**Fig. 6 - Deposits on the surface of boiler tubes at the waterside**

It is necessary to research the phenomenon of deposits (scale) that occur both inside and outside the tubes. It is necessary to test the quality of the feed water (Feed Water Composition) used in the boiler operation process. It is necessary to analyze the quality of fuel (coal) to avoid corrosion on the boiler water tubes' outer surface.

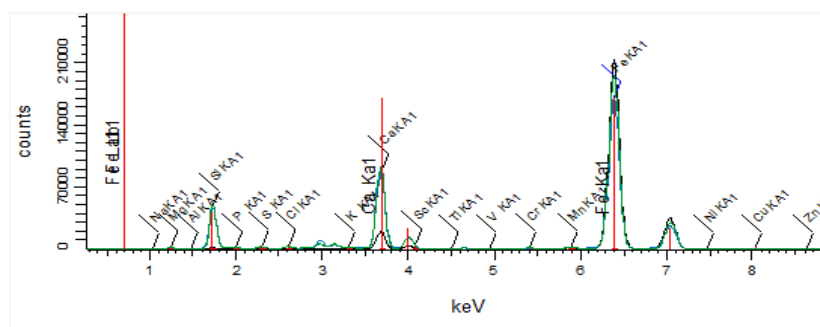
From the results of XRF testing, as shown in Table 5 and Figure 8, it can be seen that the dominant elements in the water tube boiler are solid which tends to form deposits of calcium carbonate ( $\text{CaCO}_3$ ), calcium sulfate ( $\text{CaSO}_4 \cdot 2\text{H}_2\text{O}$ ), magnesium carbonate ( $\text{MgCO}_3$ ) and strontium deposits. Sulfate ( $\text{SrSO}_4$ )

has a low forming intensity beside other scale deposits, such as iron carbonate (FeCO<sub>3</sub>), iron sulfide (FeS).

**Fig. 7 - XRF results on the surface of the crust in a water tube (water tube boiler)**

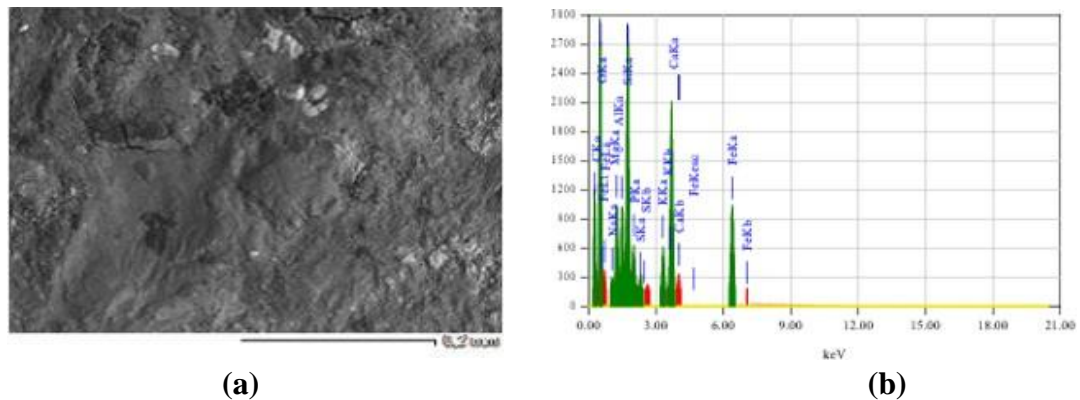
The results of the examination of corrosion products using EDS as shown in Fig.8, showed that the dominant elements which are corrosive elements that accelerate the damage of the material. The existing elements considered from the combustion of fuel in the boiler system reacted with air to form oxide compounds [14] and become corrosion products in the form of a crust attached to the tubes' outer surface.

**Fig. 8 - Results of SEM-EDS crust on the surface boiler tubes at a fireside. (a) SEM results on the surface of the tubes on the fireside; (b) EDS results in the crust on the surface of the tubes on the fireside**

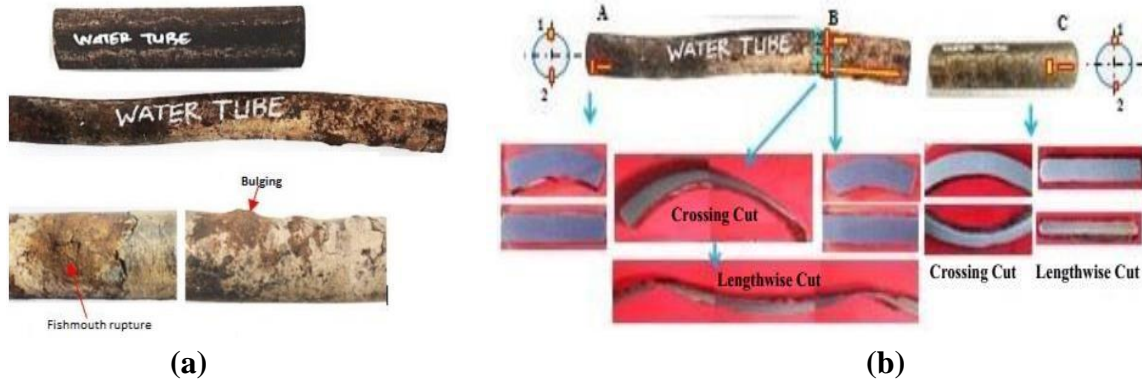
The microstructural test was conducted at two points: the damaged areas and areas that did not damage, as shown in Figure 9. Microstructure and hardness tests were conducted on two points, namely the area of tubes that were damaged and the area of tubes that were not, as shown in Fig. 9a and 9b. At Location, A Fig. 9 b), the microstructure with lengthwise cut (locations 1, 2 and 3) was in the form of ferrite (white) and pearlite, which transformed into a dispersion of pearlite at grain boundaries. At Location A, Fig. 10, the microstructure with lengthwise cut (locations 1, 2 and 3) was ferrite (white) and pearlite, which transformed into spheroidization of pearlite at grain boundaries. At Location B Figure 11, the microstructure with crossing cut (locations 1, 2, 3 and 4) was ferrite (white) and pearlite which transformed into spheroidization of pearlite at grain boundaries. At Location B Fig. 12, the microstructure (burst location) of sample 2 with crossing cut (1 and 3) was ferritic and at location 2 was ferrite-pearlite which transformed into pearlite spheroidization at the grain boundaries. At Location B Fig. 13, the microstructure samples (burst location) with crossing cut (1, 2 and 3) were ferrite and pearlite spheroidization at the grain boundaries. At Location B Fig. 14, the microstructure (burst location) of the sample 2 with lengthwise cut (1, 2 and 3) was in the form of ferrite and pearlite spheroidization at the grain boundaries. At Location C Fig. 16, the crossing cut microstructure (1, 2 and 3) was in the form of ferrite and pearlite spheroidization at the grain boundaries. At Location C Fig. 17, the microstructure of sample 1 had a lengthwise cut that extended outside in the form of ferrite and the middle (2) and the inside (3) in ferrite and pearlite spheroidization at the grain boundaries. At Location C Fig. 18, the microstructure of sample 2 with crossing cut (1) was in the form of ferrite and the middle (2) and the inside (3) was in the form of ferrite and pearlite spheroidization at the grain boundaries. At Location C Fig. 19, the microstructure of the sample 1 had a lengthwise cut extending outside in the form of ferrite and the middle (2) and the inside (3) in the form of ferrite and pearlite spheroidization at the grain boundaries. The phase degradation indicate that the tube has been experienced relatively high temperatures for a long time.

**Fig. 9 - Tubes on a fireside. (a) Tubes which show bulging at boiler tube surface of the firesid; (b) Sampling for an examination of the microstructure and hardness test on tubes**

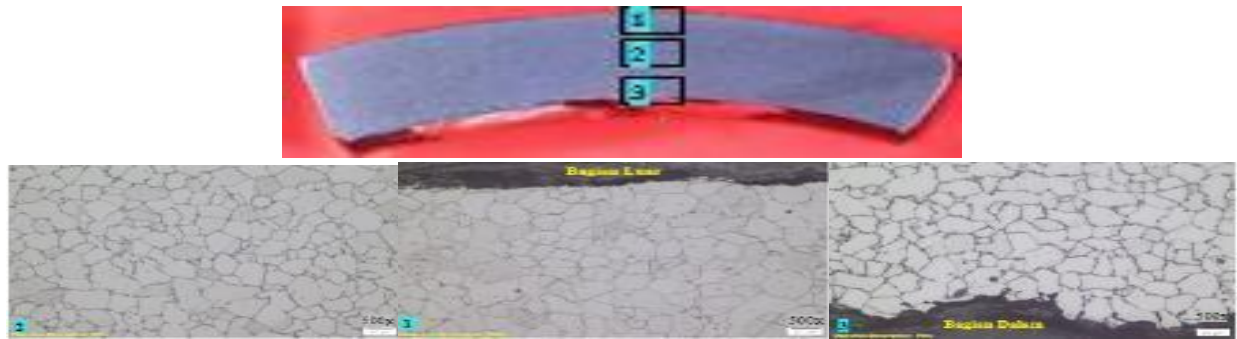
**Location A: Sample 1 Crossing Cut**

**Fig. 10 - Microstructure location A sample 1 cross-section (locations 1, 2, and 3) in the form of ferrite (white) and pearlite, which has been transformed into pearlite spheroidization at grain boundaries. Etching: nital 2%.**

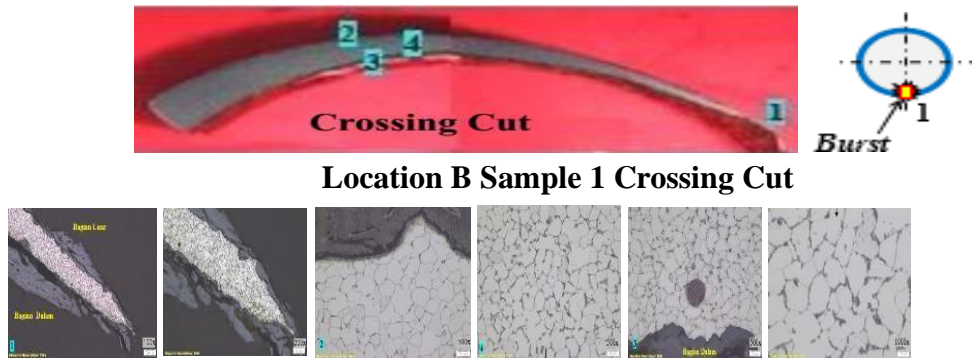
**Fig. 12 - Microstructure Location B sample 1 crossing cut (locations 1, 2, 3, and 4) in ferrite (white) and pearlite has been transformed into pearlite spheroidization at grain boundaries. Etching: nital 2%**

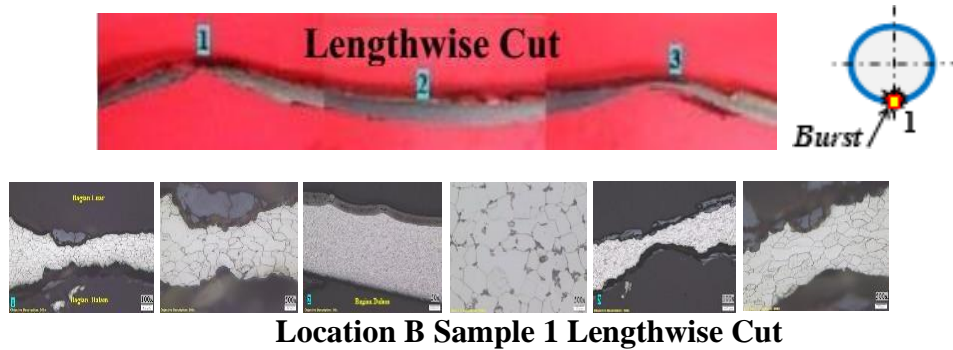
**Fig. 13 - The microstructure of Location B (burst location) sample 2 cross-sections (1 and 3) is ferritic and at location 2 is ferrite-pearlite which has turned into pearlite spheroidization at the grain boundaries. Etching: nital 2%**

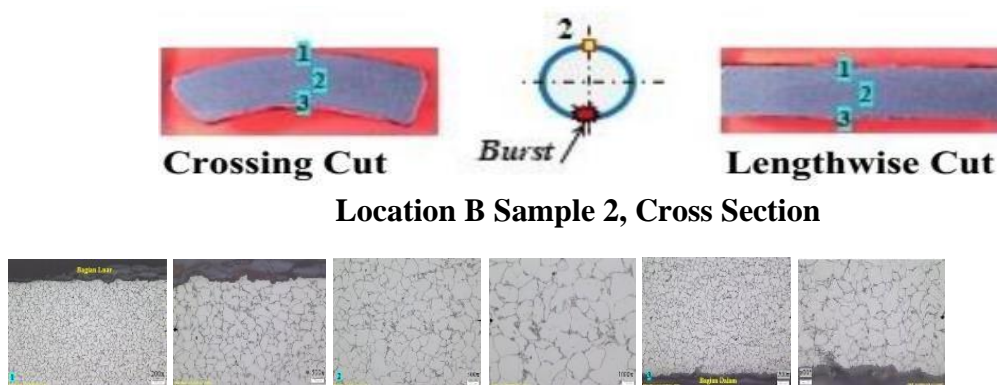
**Fig. 14 - The microstructure of Location B (burst location) samples 2 crossing cut (1, 2 and 3) in**

the form of ferrite and pearlite spheroidization at the grain boundaries. Etching: nital 2%

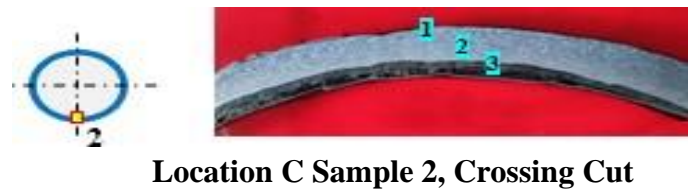
**Location C Sample 2, Crossing Cut**

**Fig. 18 - Microstructure Location C sample 2 crossing cut (1) in the form of ferritic and in the middle (2) and the inside (3) in the form of ferrite and pearlite spheroidization at the grain boundaries. Etching: nital 2%**  
**Location C Sample 2, Lengthwise Cut**

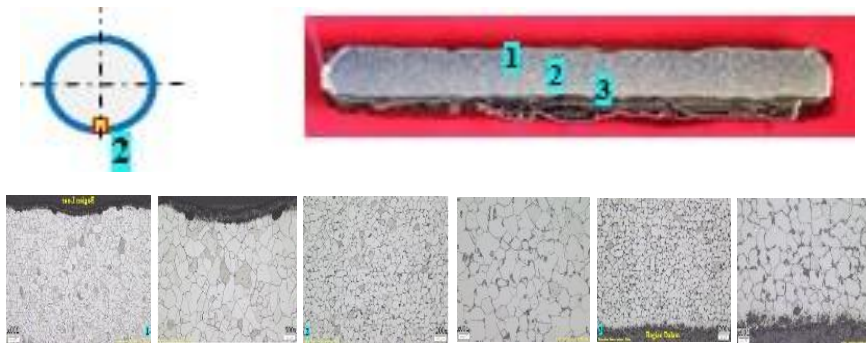
**Fig. 19 - Microstructure Location C sample 1 lengthwise cut of ferritic and middle (2) and inner (3) of ferrite and pearlite spheroidization at grain boundaries. Etching: nital 2%**
