## **ASSESSMENT AND ANALYSIS OF THE PERFORMANCE OF COMBINATION BOILER**

**Omical Asanta<sup>1</sup>, Dedi Priadi<sup>2</sup> and Desiran Sembiring<sup>3</sup>**

This study evaluated the performance and condition of a combined water-tube and fire-tube boiler system. The boiler, with a design capacity of 20 t/h, has been in operation since 2011 and utilizes a circulating fluidized bed (CFB) combustion system fueled by low-grade coal. The assessment included visual inspection, material thickness measurements, ultrasonic testing of weld joints, non-destructive testing (Dye Penetrant Testing), hardness testing, and in-situ metallography. The objectives of the assessment were to determine the extent of wall thinning due to corrosion, erosion, or creep; to identify defects in the boiler material and welds through non-destructive testing; to assess metallurgical and mechanical degradation caused by thermal aging, overheating, fatigue, creep, stress corrosion cracking (SCC), or other degradation mechanisms; and to evaluate the current condition and estimate the remaining life of the boiler to determine whether it is still serviceable, repairable, or requires replacement or depressurizatio

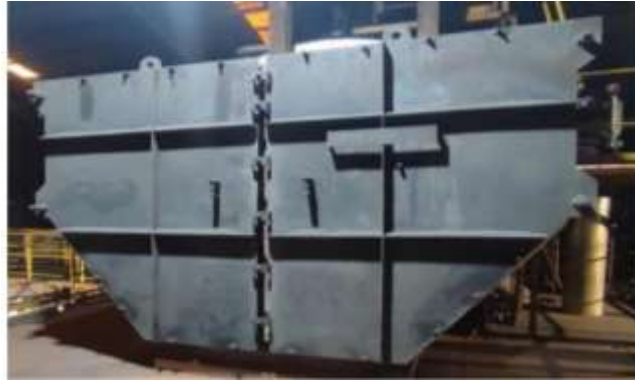
***Figure 2 Boiler Shell***

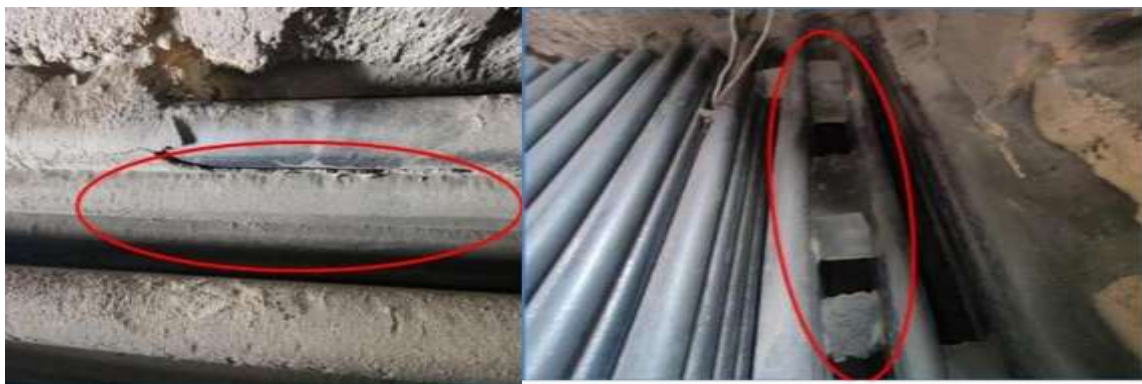
- Furnace and Refractory: A significant gap was observed between the furnace door and the adjacent wall, presenting a critical risk of heat leakage. Furthermore, extensive cracking and peeling were documented across the refractory lining, compromising the structural insulation.

***Figure 3(A). Visual inspection of the water tank in Compartment 1 (West) and (B) Visual inspection of the water tank in Compartment 1 (East) - Furnace***

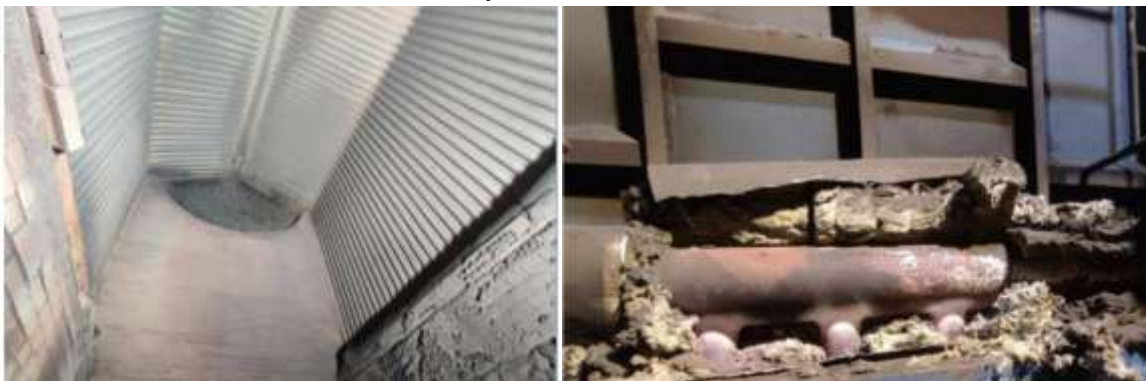
- Tube Conditions: An anomaly in the tube configuration was discovered in Compartments 1 and 2, where one tube was intentionally cut and blocked. Fireside surfaces of the water and fire tubes were coated with extensive layers of coal combustion residue. Minor abrasion and corrosion ( $\pm 0.5$  mm) were observed on the water tubes over 14 years of service.

***Figure 4(A). Visual inspection of Wall Tubes in the furnace and (B) Visual inspection of Header 1 (West)***

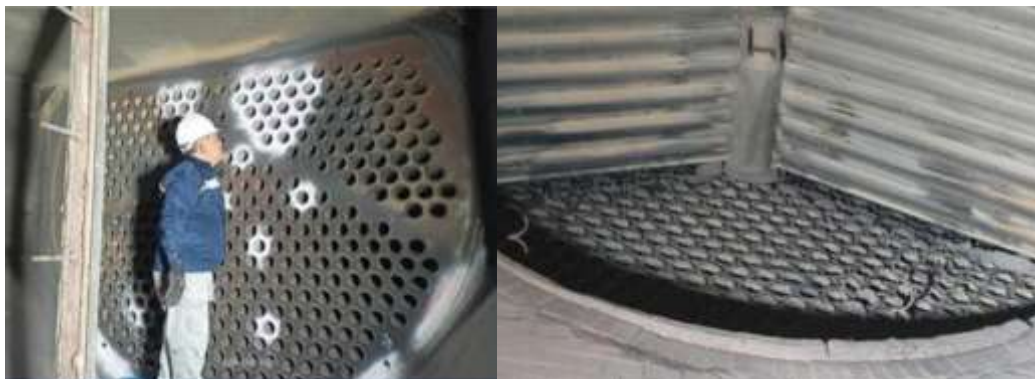
***Figure 5 (A). East side of the Pipe Plate and (B) The West side of the pipe plate is filled with crust from combustion residue.***

Chemical analysis of the deposits and feedwater using EDS and XRF indicates that the crust on the fireside of the tubes is primarily composed of corrosive elements (Fe, Si, S compounds). The boiler feedwater laboratory analysis confirms that water quality is currently maintained within safe operational limits.

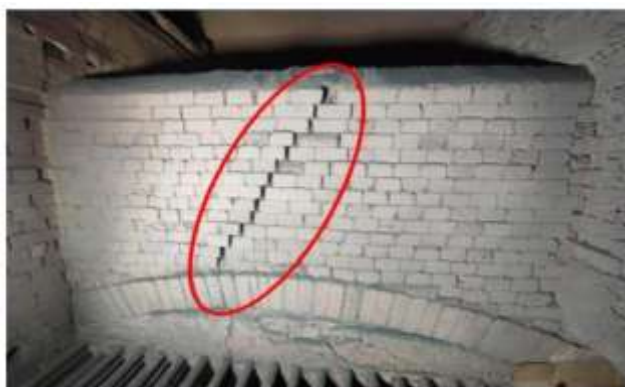
***Figure 6 Cracks in the wall in the furnace area in the partition area.***

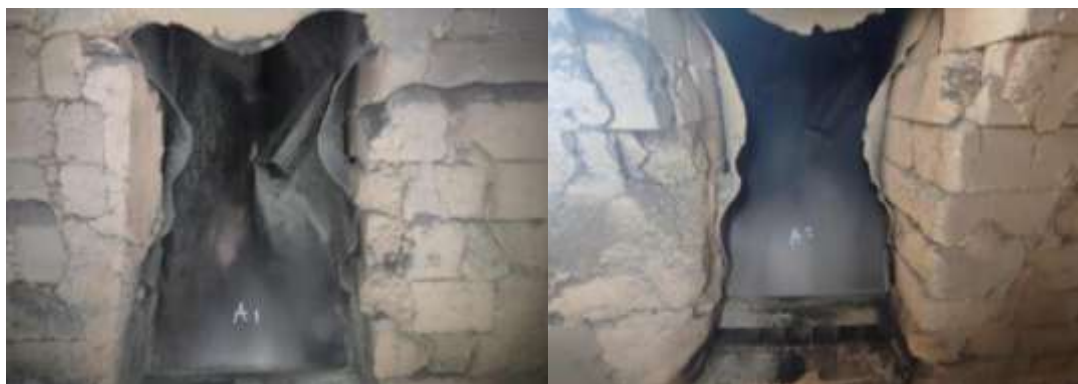
***Figure 7 (A). Fuel Line Plate Compartment (Coal) 1 (North) (B) Fuel Line Plate Compartment (Coal) 2 (North)***

- Header and Nozzle Integrity: Severe external corrosion was detected on the header. Deformation was observed on the nozzle plate at the fuel feed port (North side), likely attributed to localized overheating.
- Structural Welds: The supporting structure and nozzle welds were found to be in optimal condition.

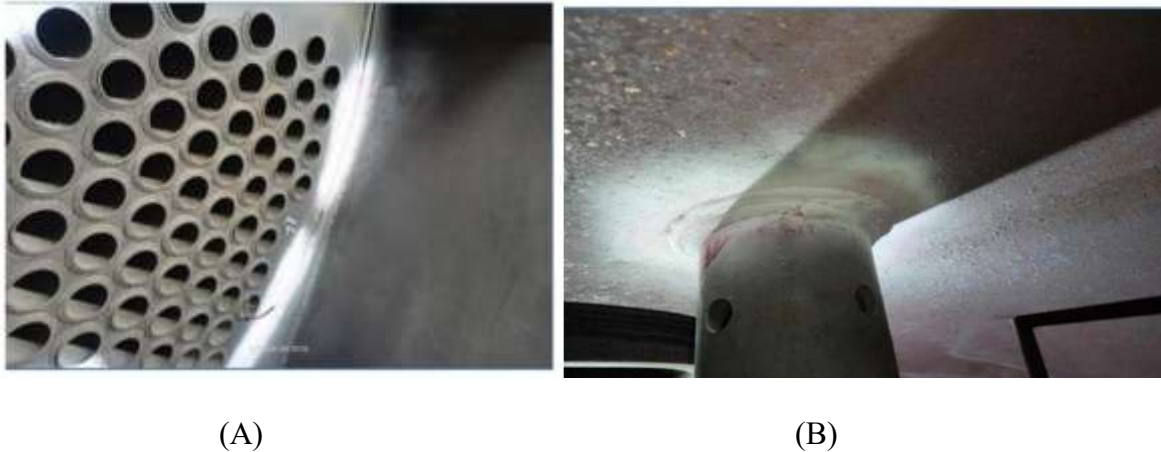
Dye Penetrant Testing (DPT) applied to the pipe-to-shell sheet, pipe-to-tube sheet, and drum nozzles revealed an absolute absence of surface defects, cracking, or porosity. Similarly, Ultrasonic Flaw Detector testing on the critical "T" joint welds of the steam-side shell confirmed high-quality workmanship with no detectable sub-surface flaws.

***Figure 8 (A). Dye Penetration Test on Tube Sheet (East) and (B) Dye Penetration Test on Nozzle***

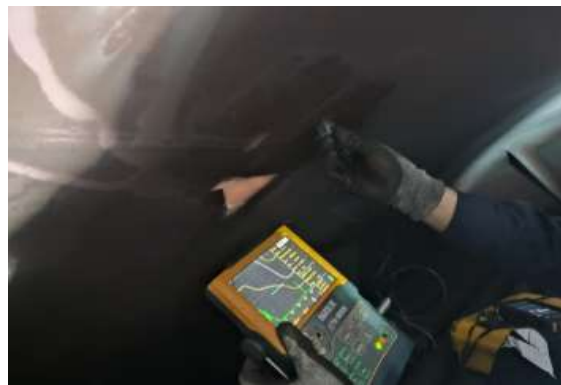
***Figure 9 Ultrasonic Test on steam side shell “T” connection***

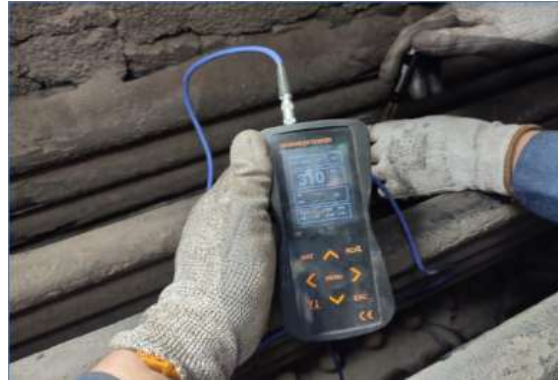
Portable hardness testing was utilized to evaluate mechanical degradation. The findings are summarized in Table 5. The hardness assessment reveals that the primary structural components exhibit mechanical properties consistent with their design specifications.

**Figure 10 Hardness testing on Water Tube compartment 1**

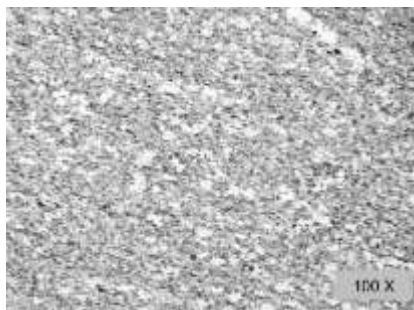
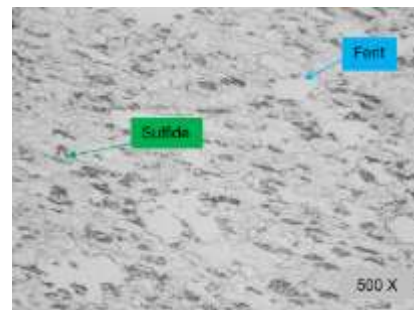
**Figure 11 In-situ metallography of Water Tube Compartment 2 (East), Tube No. 2 Layer 1 (Material: BS 3059 Part 1:1987 Gr.320 ERW). (A) Microstructure at 100X magnification showing a normal ferritic matrix with sulfide impurities (Hardness: 97 HB; Etchant: 8% Nita**

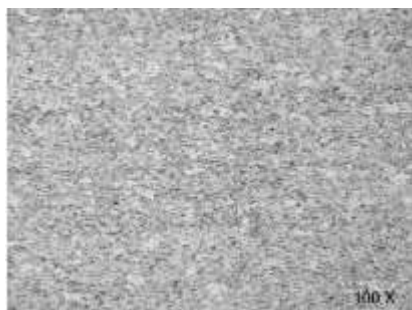
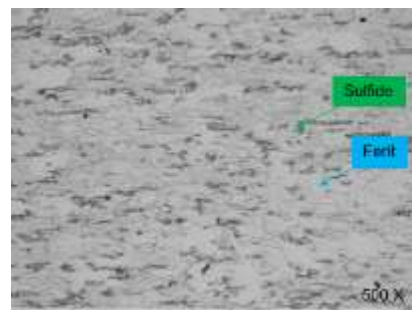
**Figure 12 In-situ metallography of Water Tube Compartment 2 (West), Tube No. 2 Layer 1 (Material: BS 3059 Part 1:1987 Gr.320 ERW). (A) Microstructure at 100X magnification indicating a normal condition with a ferritic matrix (white) and sulfide impurities (black)**

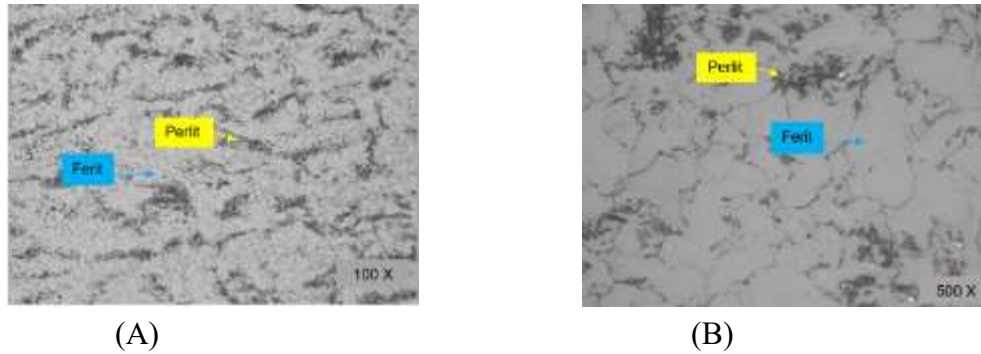
**Figure 13 In-situ metallography of Header (Material: SA 106 Gr.B). (A) Microstructure at 100X magnification indicating a normal condition with ferrite (white) and spheroidized pearlite (black) (Hardness: 108 HB; Etchant: 8% Nital). (B) Enlarged view at 500X magnification**

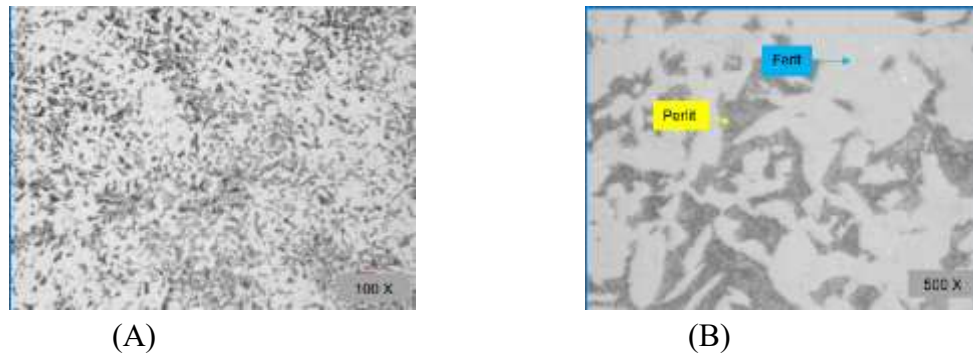
**Figure 14 In-situ metallography of Tube Plate/Tube Sheet (Material: SA 515 Gr.70). (A) Microstructure at 100X magnification indicating a normal condition with coarse-grained ferrite (white) and pearlite (black) (Hardness: 157 HB; Etchant: 8% Nital). (B) Enlarged view at 500X magnification**

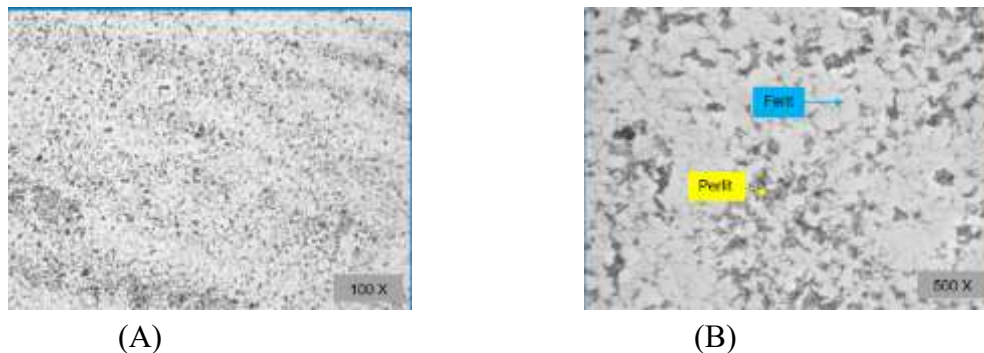
**Figure 15 In-situ metallography of Shell Drum (Material: SA 515 Gr.70). (A) Microstructure at 100X magnification indicating a normal condition consisting of ferrite (white) and pearlite (black) (Hardness: 151 HB; Etchant: 8% Nital). (B) Enlarged view at 500X magnification**

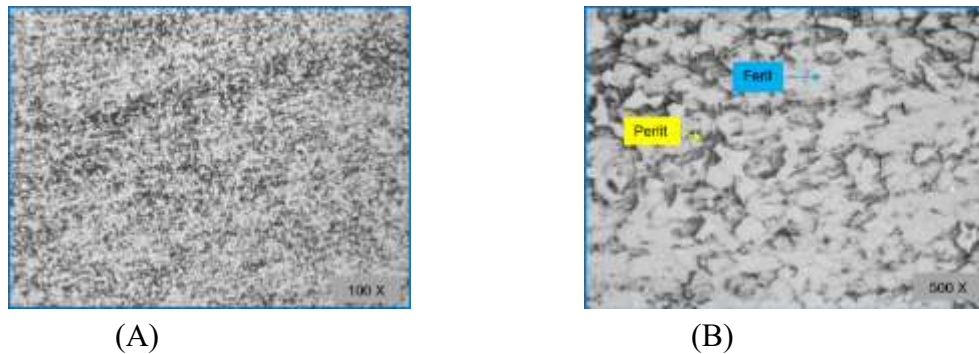
**Figure 16 In-situ metallography of Fire Tube (Material: BS 3059 Part 1:1987 Gr.320 ERW). (A) Microstructure at 100X magnification indicating a normal condition with ferrite (white) and pearlite (black) (Hardness: 91 HB; Etchant: 8% Nital). (B) Enlarged view at 500X magnification indicating a normal condition with ferrite (white) and pearlite (black) (Hardness: 91 HB; Etchant: 8% Nital).**

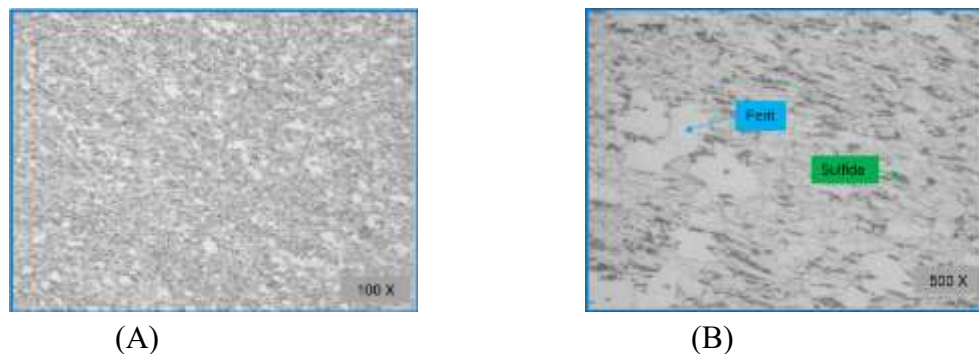
**Figure 17 In-situ metallography of Water Tube No. 3 Layer 4 (Material: BS 3059 Part 1:1987 Gr.320 ERW). (A) Microstructure at 100X magnification indicating a normal condition with ferrite (white) and sulfide impurities (black) (Hardness: 102 HB; Etchant: 8% Nital). (B) Enlarged view at 500X magnification indicating a normal condition with ferrite (white) and sulfide impurities (black) (Hardness: 102 HB; Etchant: 8% Nital).**

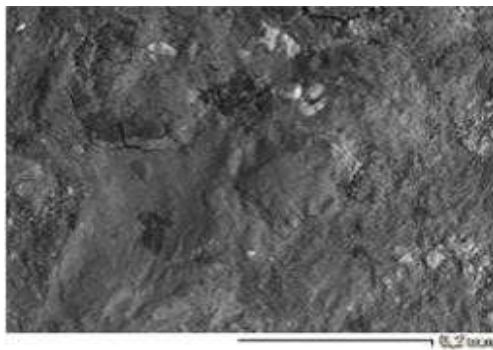
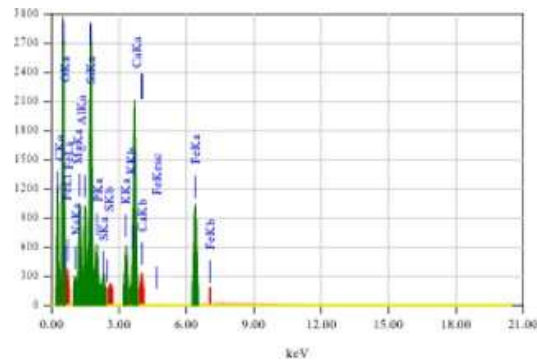
**Figure 18 Results of SEM-EDS crust on the surface boiler tubes at a fireside. (A) SEM results on the surface of the tubes on the fireside; (B) EDS results in the crust on the surface of the tubes on the fireside**

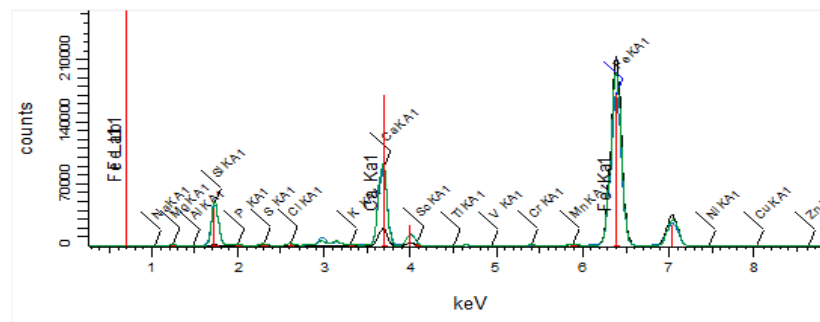
**Figure 19 XRF results on the surface of the crust in the water tube boiler**
