To cite this article: Desiran Sembiring, Daud Surbakti and Ab Saman (2025). FAILURE ANALYSIS OF WATER TUBE BOILER: CASE STUDY AT TEXTILE PROCESSING PLANT, International Journal of Current Research and Applied Studies (IJCRAS) 4 (2): Article No. 116, Sub Id 199

## **FAILURE ANALYSIS OF WATER TUBE BOILER: CASE STUDY AT TEXTILE PROCESSING PLANT**

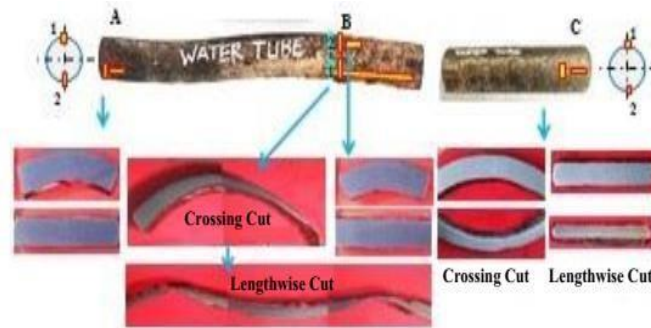
**Fig 4. Sample collecting position for hardness test on tubes**

Hardness testing is carried out on the damaged area and the undamaged area according to figures 4 and 5, where each region gets data 3 times. The comparison of hardness testing of the damage tubes and intact tubes showed that the hardness decreased in areas far from the burst around 117-105 HV, but the hardness increased in the burst area 117 - 119 HV due to a change in the ferrite-pearlite phase into pearlite spheroidization (Fig. 14). However, when compared to standard ASTM 213 material, its hardness value is 178 HV. This is away different from the intact water tube boiler material. It means that the tube's material used has a hardness value of 117 HV. Table 4 showed the tensile test result of the specimens. The tubes' overall tensile strength is reduced due to a softening process caused by annealing temperature > 550 °C. The tensile strength decreased by approximately 11.5% and a yield strength decline of about 16.25% as well as the elongation decreased by around 14.8%. However, when compared with the standard ASTM 213 material, it is not much different from the intact tube material, meaning that the tube material which was chosen and used was good.

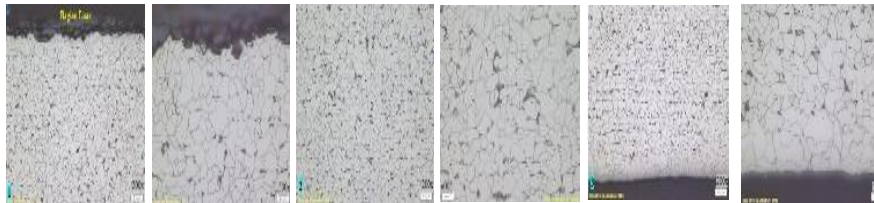
In Fig. 20 dan Fig. 21 showed the microstructure material of standard intact water tubes boiler (ASTM A213 T12). Samples 1 and 2 of the crossing cut and lengthwise cut (locations 1, 2 and 3) were ferrite (white) and pearlite (black). The intact tube shows have no degradation phase, so that it can be used as a reference to comparison.

**Fig. 21 - The microstructure of the normal sample tube 2 pieces lengthwise (locations 1, 2 and 3) in the form of ferrite (white) and pearlite (black). With fine grains resulting from the formation process. Etching: nital 2%**
